From idea to realisation of a trolleybus corridor in Szeged

dr. Zoltán Ádám Németh
Szeged Transport Company

International Trolleybus Transferability Conference

Trolleybus intermodal corridor pilot action: reconstruction of the overhead wires in the Híd utca – Vár utca junction in the city center.

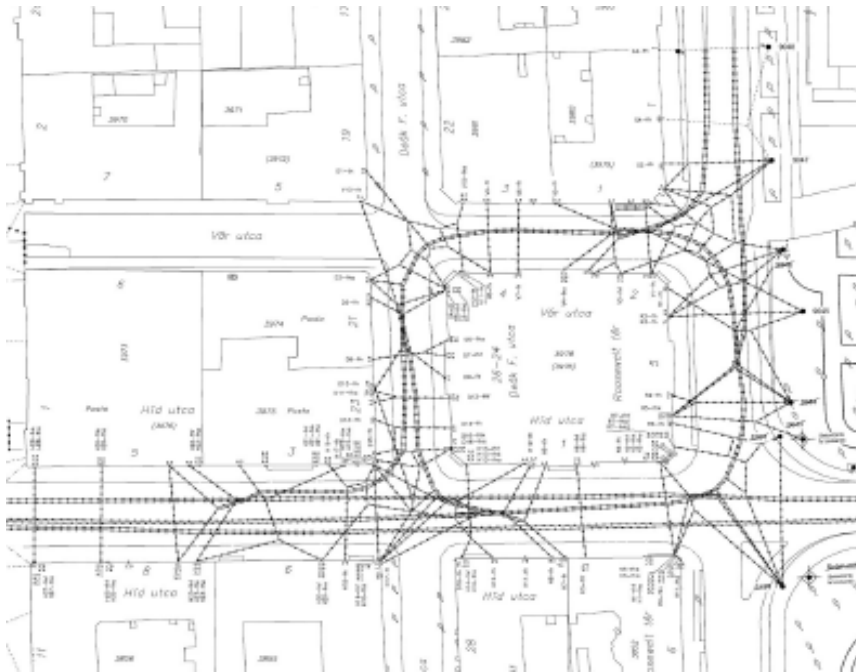
Pre-project:

The trolleybuses were allowed on turnouts and crossings with reduced speed, with the risk of derailments.

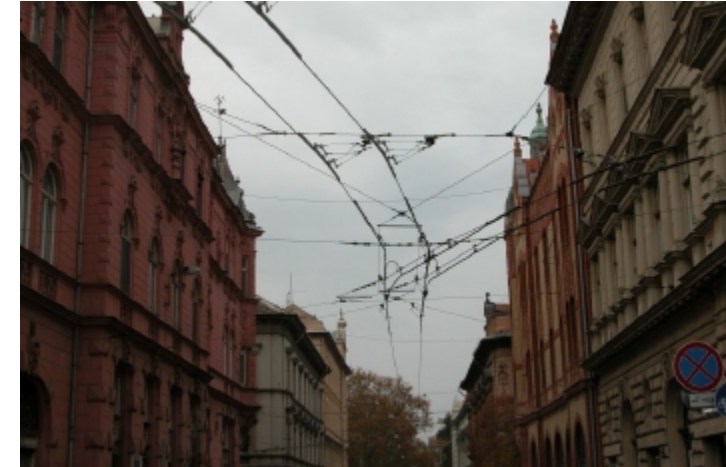
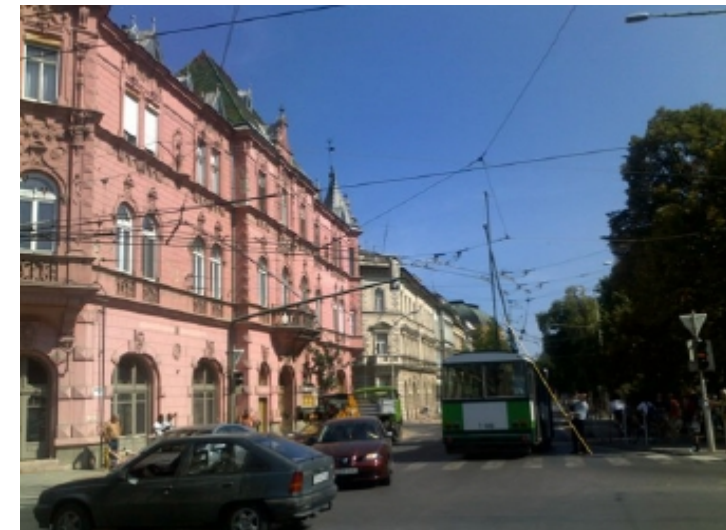
Modern overhead elements:

- High-speed turnout
- Delta-hanging

With modern trolleybus overhead elements it is possible to increase the speed of the vehicles. With other road construction elements we can have a flexible and environmentally friendly transport mode.

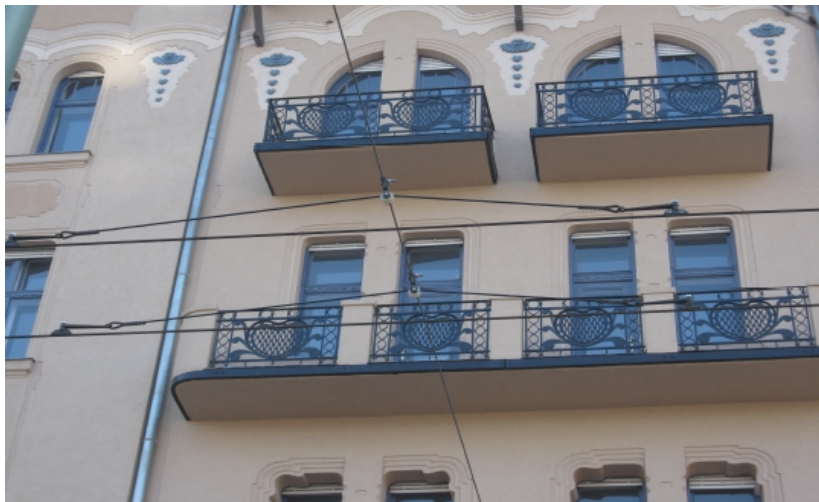
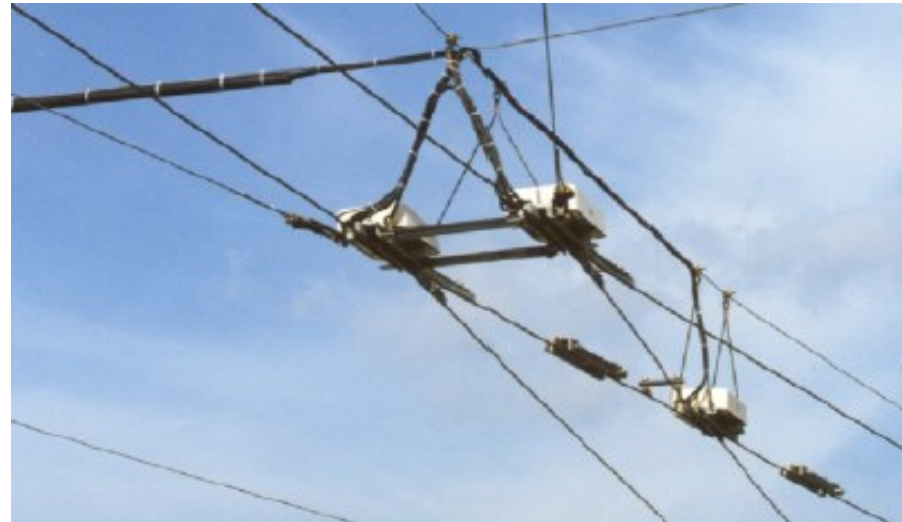
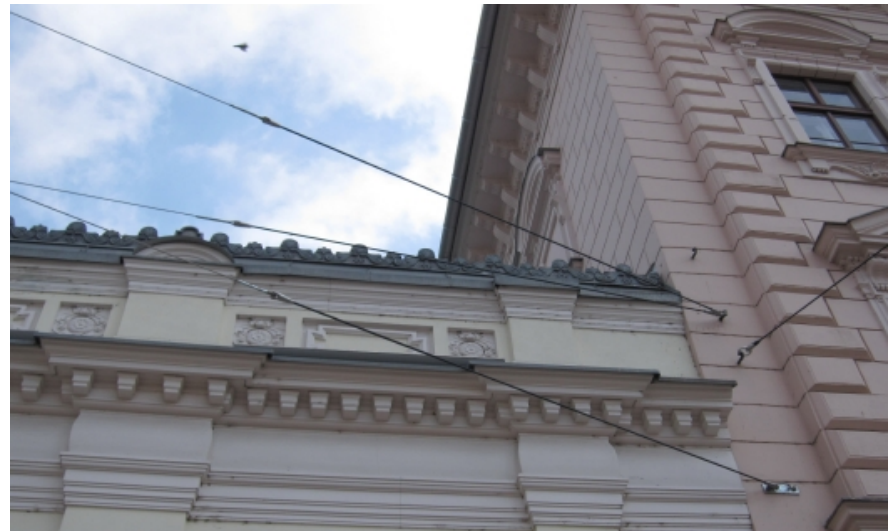
- Parafil isolators

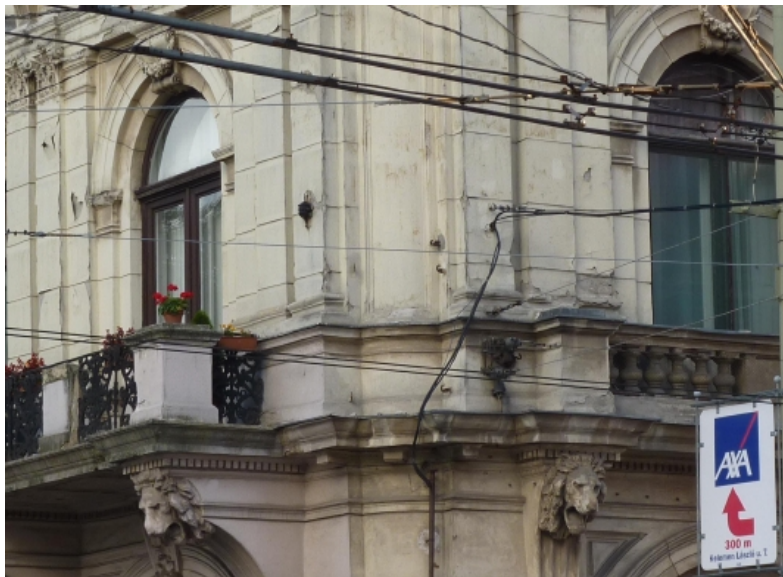
Property problem: Hooks

Three categories:

municipality owned buildings
state or company owned buildings,
more than one owners

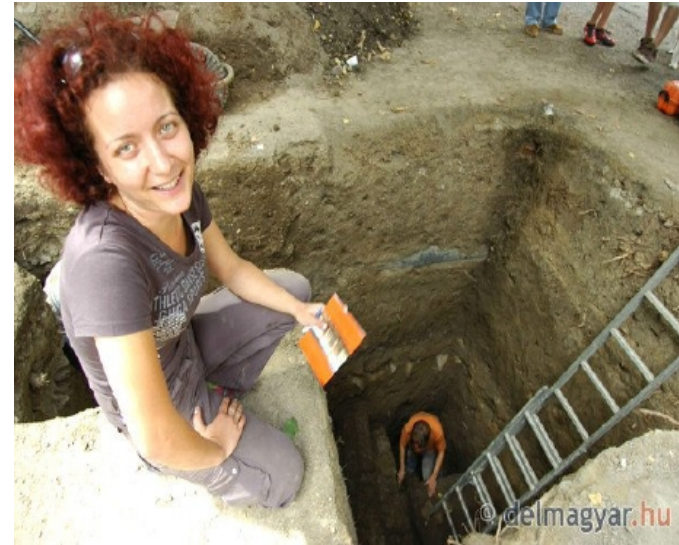
Archeology & trees:

- One of the fund of a mast was suspected to be on top of the ancient wall of Szeged fortress, which is 4-5 meters below surface.
- The greenery and archeology together made impossible to exchange one of the existing masts.

A föld alatti történelmi emlékek épségének megőrzése végett a trolibusz forduló felújításakor új oszlop telepítése helyett a meglévő oszlopot kikötöttük.

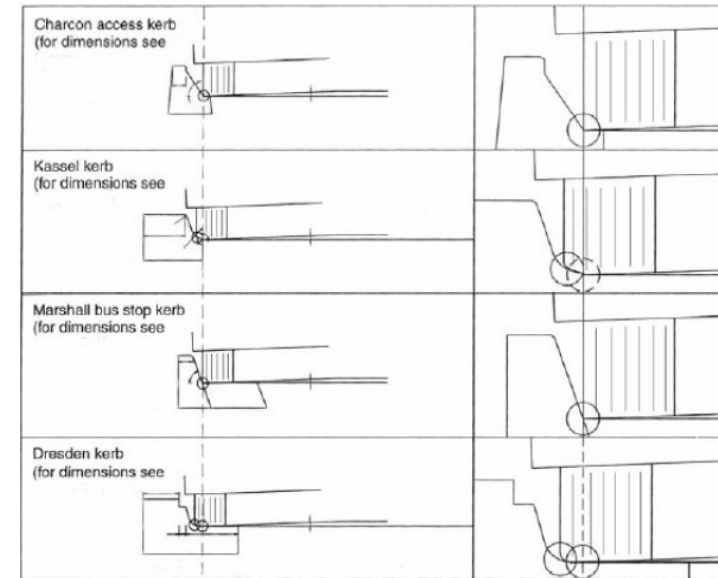
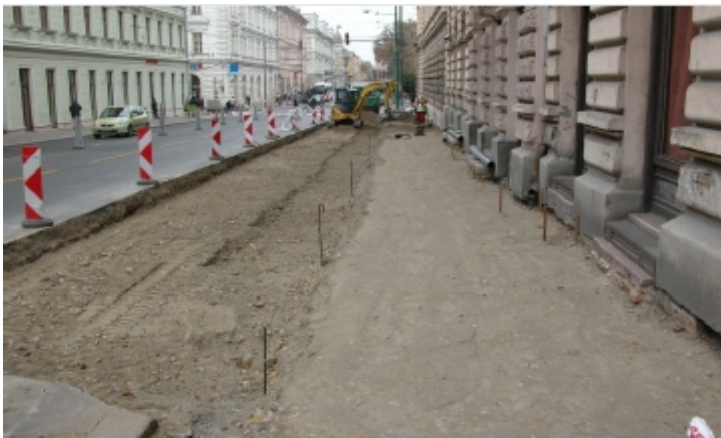
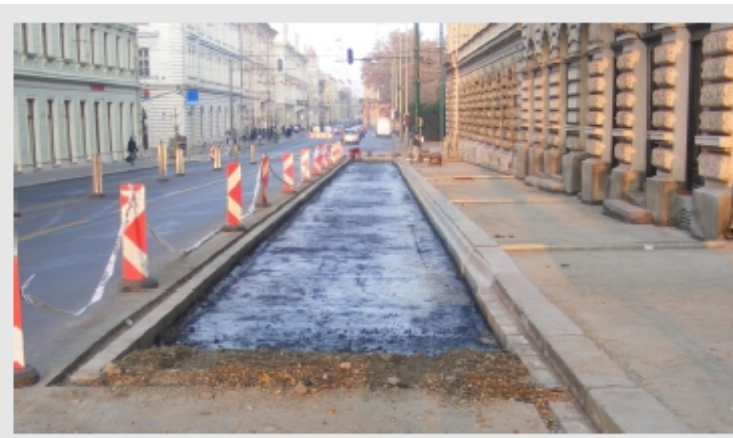
Reconstruction of the Híd utca trolleybus stop:

- Introducing low-floor accessibility kerb elements.
- Implementation problems: the levels of the pavements were incorrect, the drain system had to be changed on spot.
