**Report on the authorization and implementation of the  
reconstruction of Szeged Híd utca / Vár utca trolleybus junction's  
overhead wire and trolleybus stop**

Szeged Transport Company

2012.

**Trolley – Promoting Electric Public Transport**

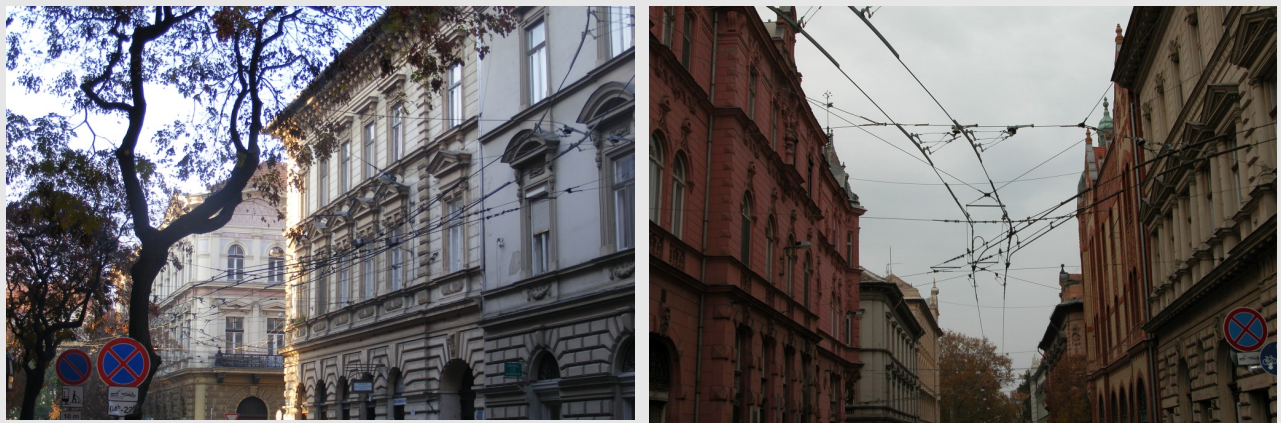
*The trolley catenary situation at Deák Ferenc utca and Vár utca before the project*

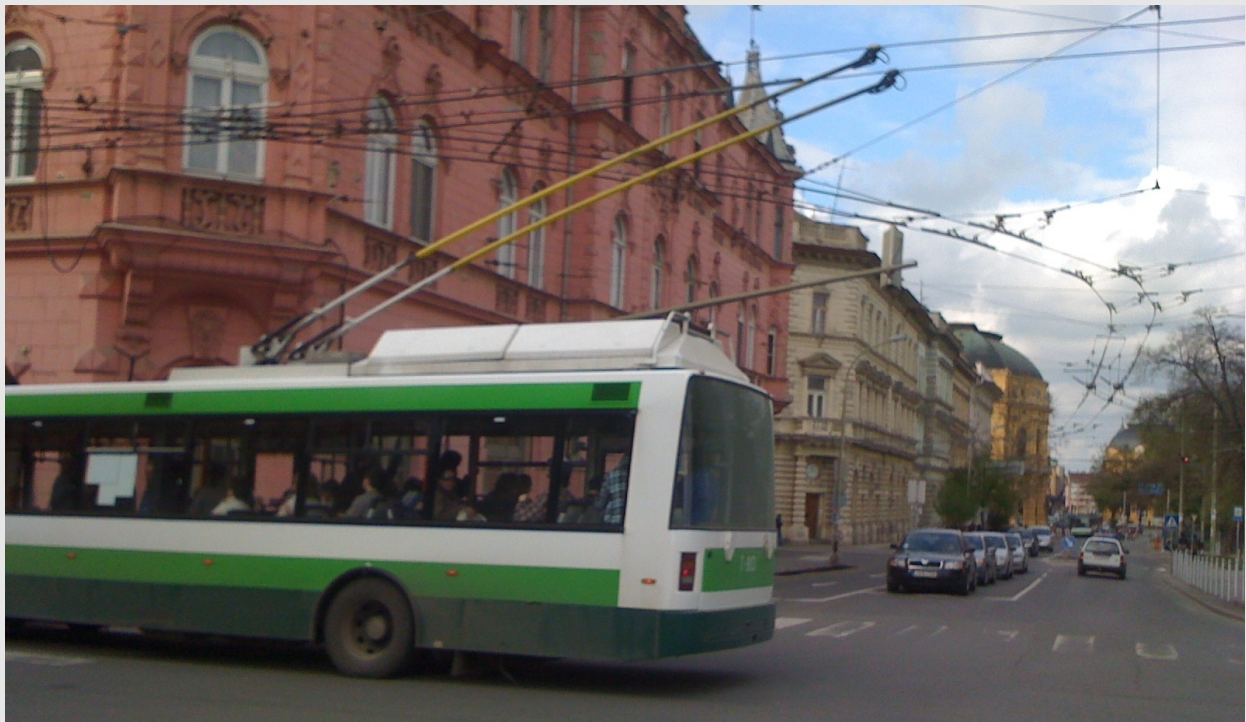
*The old catenary at the bridge head with a crossing and a turnout*

The project area in the previous stage contained five turnouts (two of them are bifurcations operated by the trolleybus driver) and two crossings. These were built in 1985, with Kummeler-Matter system. In this system the crossings' and the turnouts' wire system are supporting a series of tubes, that actually guide the trolleybus's contact shoes. The disadvantage of this system is that these tubes can get loose leading to the loss of guidance and to derailments. The tubes also cause vertical irregularities leading to the increased possibility of trolleys to jump out at higher speeds. These elements mean a 10-15 km/h speed limit to the trolleybuses. This system requires constant maintenance and checking.

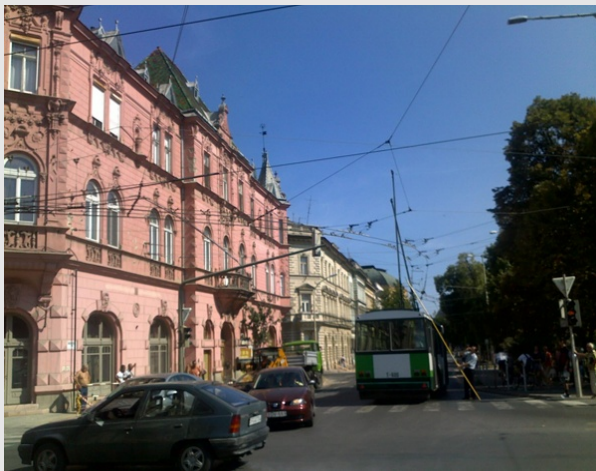
*The old overhead elements lead often to derailments and interruption of the traffic*

The new layout was designed with the crossing elements and turnouts from the Czech firm Elektroline's catalog. There is principal difference from the old trolleybus elements, that there are no tubes, which makes the whole system lighter, and vertically smoother by the strained wires that the trolley's contact shoes use. There are special crossing and turning point elements that has to be cut directly to their geometrical place. Elektroline offers a wide variety, but finite number of geometry for these special elements. The designer's job is to fit the most suitable element from the catalog in his layout geometry. These elements can be used up to 40 km/h speed with significantly lower risk of derailment.

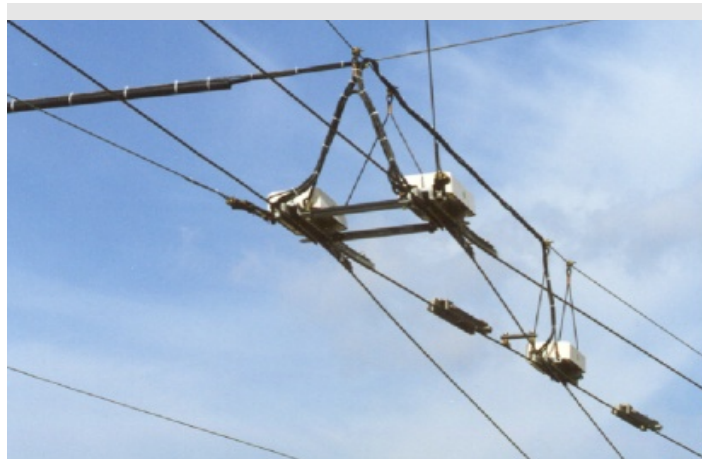
*Modern strained trolleybus symmetric 10° turnout*

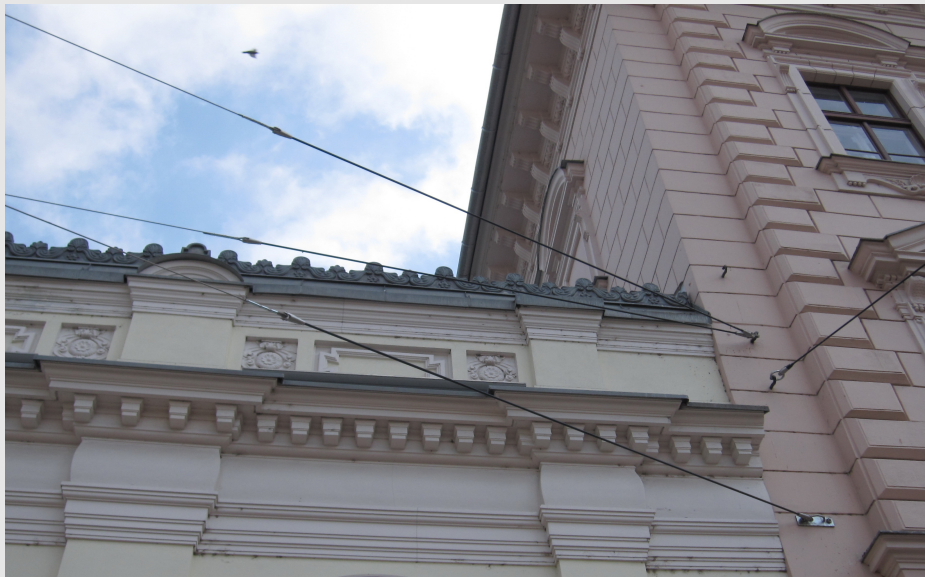
As it will be described later, we used hooks on the walls of the buildings extensively. In order to decrease the noise and vibration conducted to the walls through the wire, we used at the end of each hook a parafil element. Parafil not just insulates, but also elastic and can diminish the vibrations. These parafil inserts are also used at the “delta” type hanging that we used for straight wire sections.

*New hooks on the wall with elastic parafil insert*

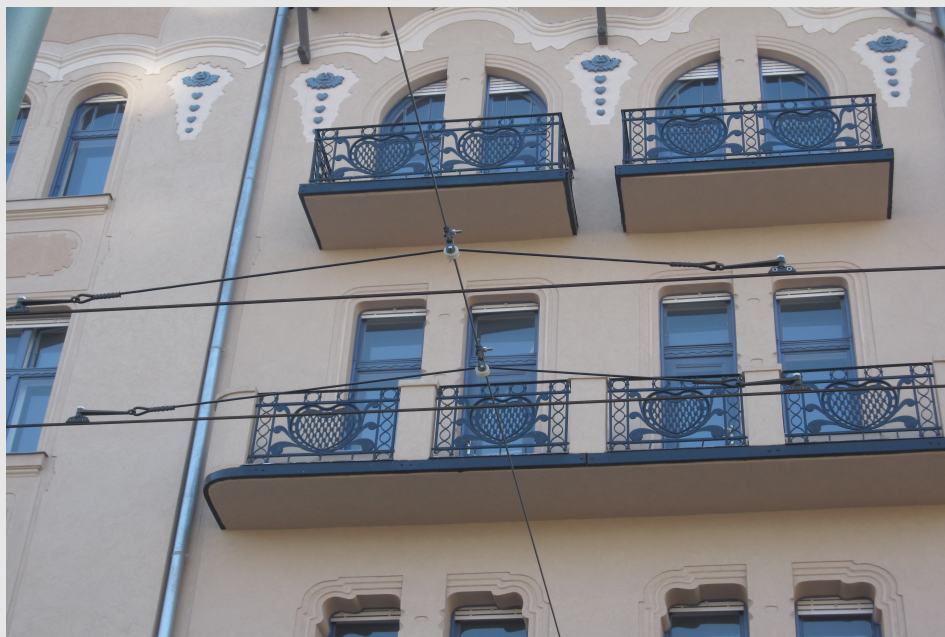
*The "delta" type hanging that we used on straight sections*

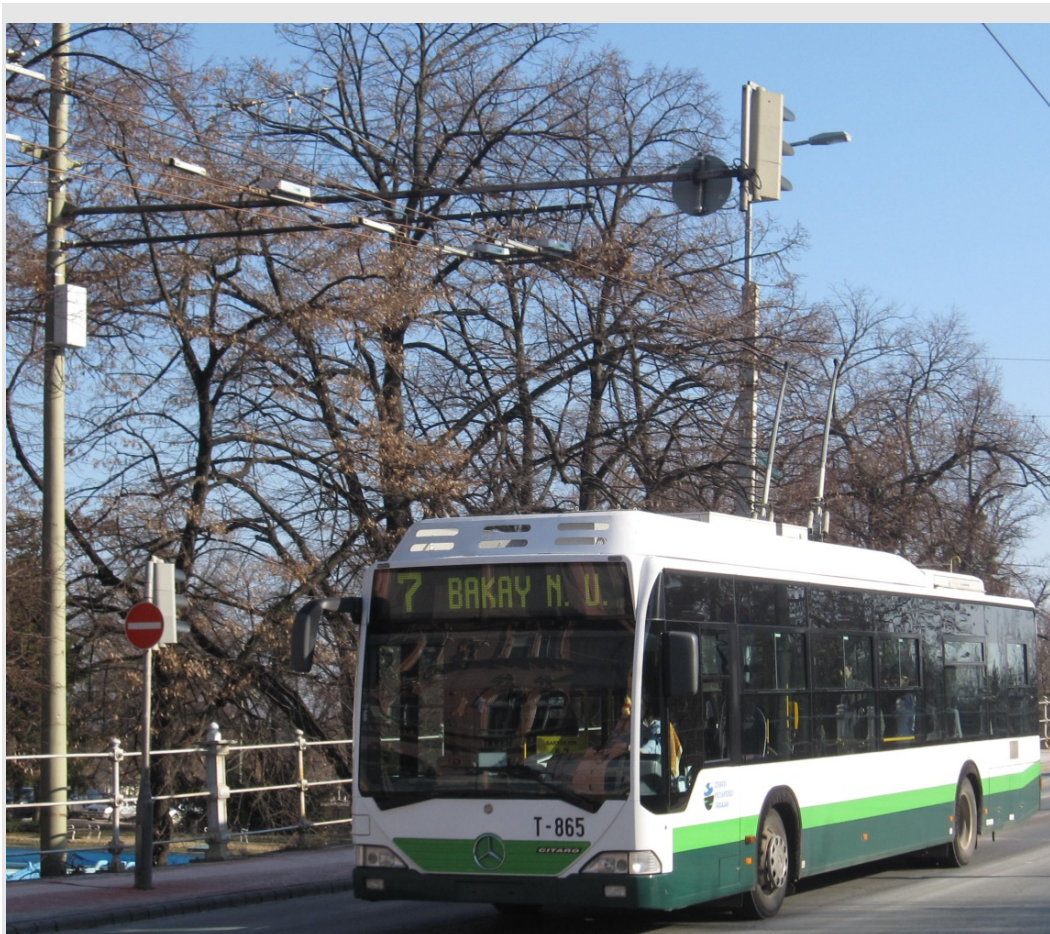
**It is always advantageous by masts to use holding arms instead of spanning wires to support the catenary**, although architecturally wires are usually better. Spanning wires always need to be strained, thus giving bigger force on the supporting mast which also means bigger foundation. However, naturally spanning wires are the natural choice in case of wall hooks.

*The holding arm for the switch at the bridge head for the turnout, that has no anchoring. Its produces relatively small extra force on the mast, so we could use the existing mast of the traffic-lights. In the background behind the trolleybus one can already see one of the unknown type of rectangular masts that are used on the bridge*

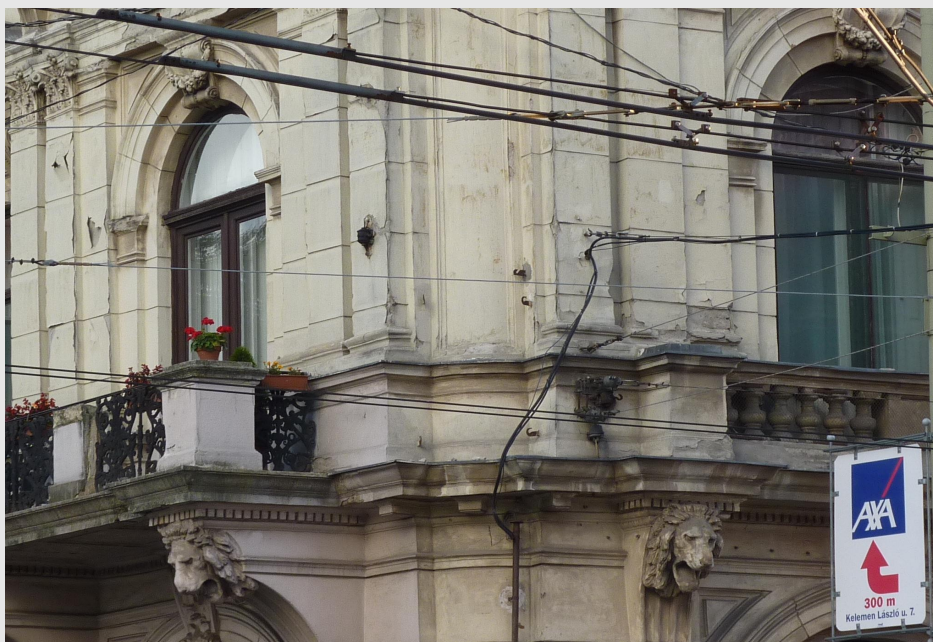
*Different used and unused hooks of the trolleybus catenary on a private building before the project. One can spot a historic unused one, which belonged since 1909 to the ancient tram*

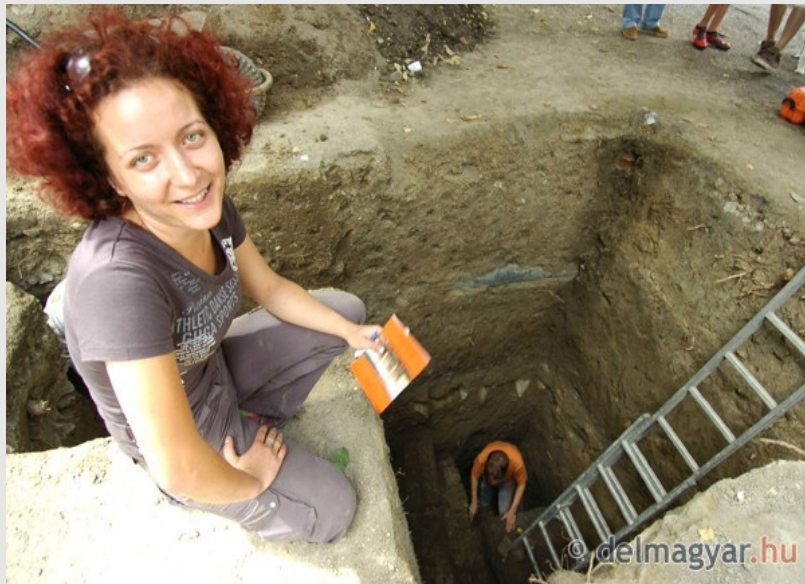
The result was sensational for the Museum in July 2011, but very disheartening for the project: in this supposedly clean new location, after the Museum dug around a 6 meter deep hole, they found further parts of the wall of Szeged castle, which the archeologists later theorized belonged to one of the gates guard houses. The committee from the Museum, the Cultural Heritage Authority, the

*Archeology for the never erected auxiliary mast's foundation in Móra park, the sensational finding of Szeged castle's guard house (from the local newspaper Délmagyarország)*

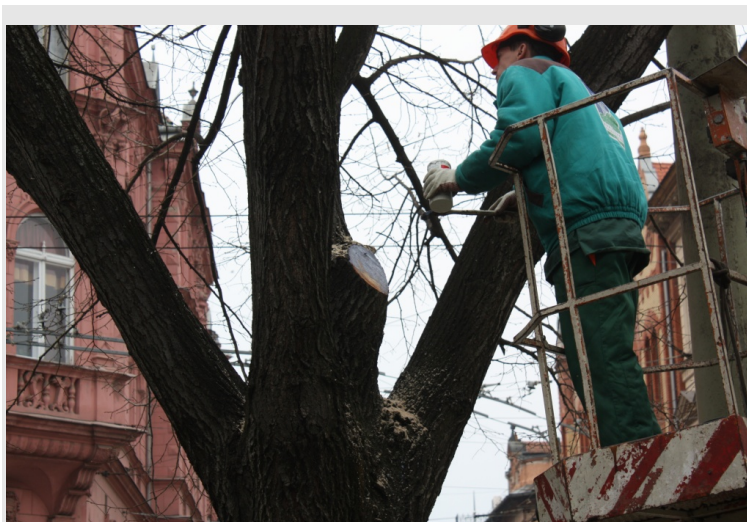
*Cutting tree branches in March 2011, seven months before the actual works*

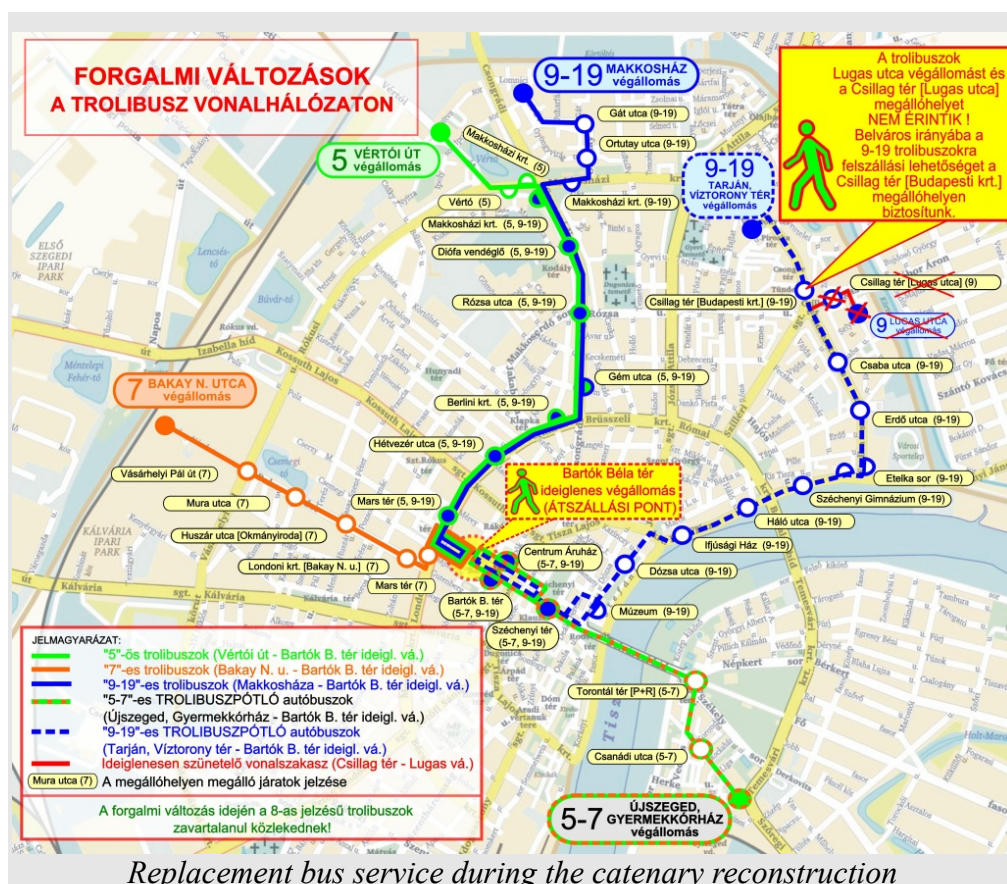
The implementation was done by the overhead repairing crew and the track maintenance crew of Szeged Transport Company, in two month. The project was implemented from November 2011 until January 2012. For three weeks no trolleybus could run in this area, and replacement buses were used. Then withing two weeks gradually we reintroduced the trolleybus service: first on route 5, than two weeks later on route 9 as well. The rest of the turning directions were finished by the end of January 2012. The works could only be carried through during the night not to disturb the normal day traffic. After the trolleybuses route 5 came back, in the evening there was an early shutdown of power, and the last evening services were carried out by buses. In January, only in the four hours of service brake was suitable for finishing works.

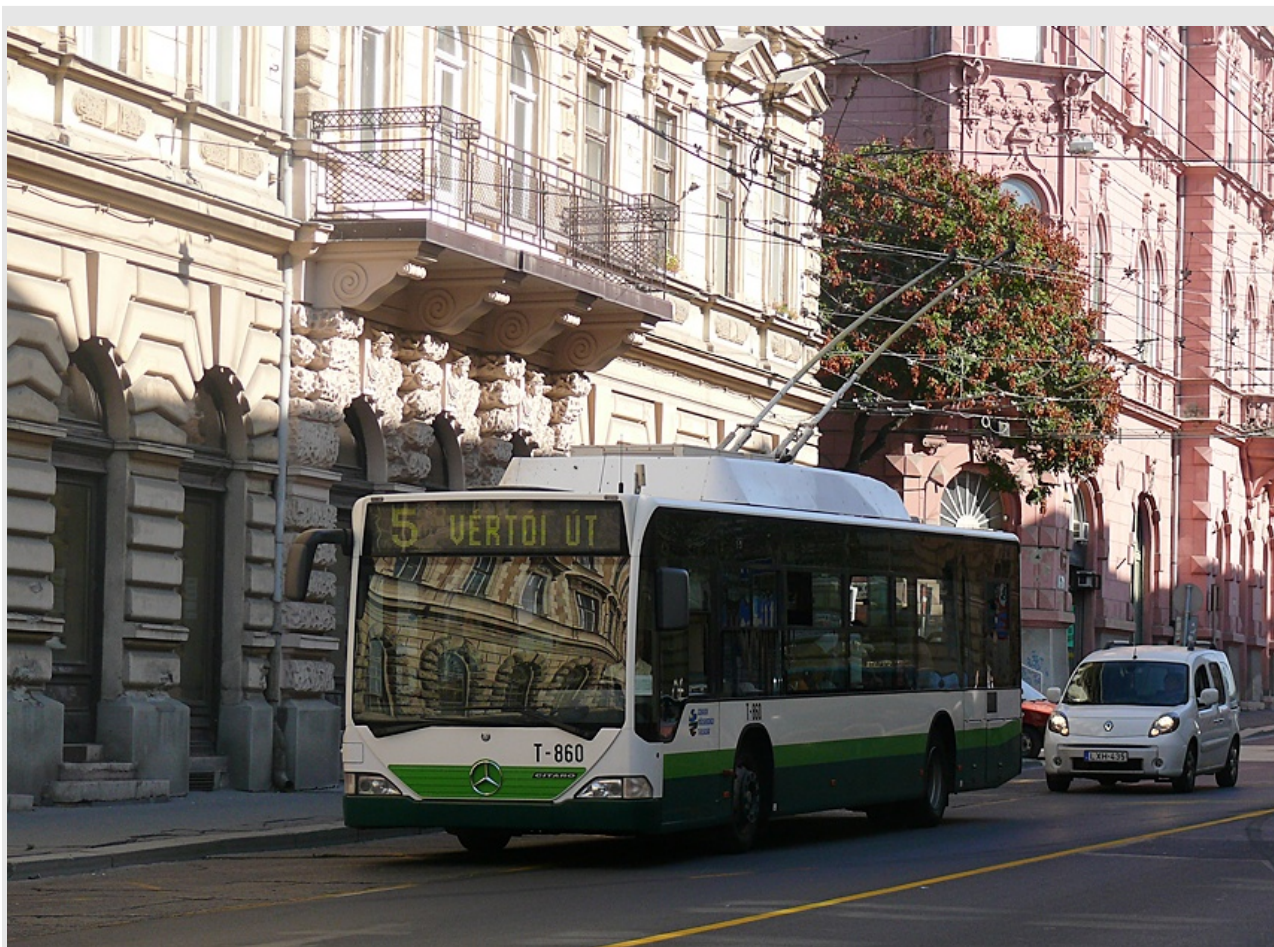
*The pre-project state of the stop. Notice the cracked asphalt sidewalk in front of the post-office building and the worn down concrete pavement of the road surface*

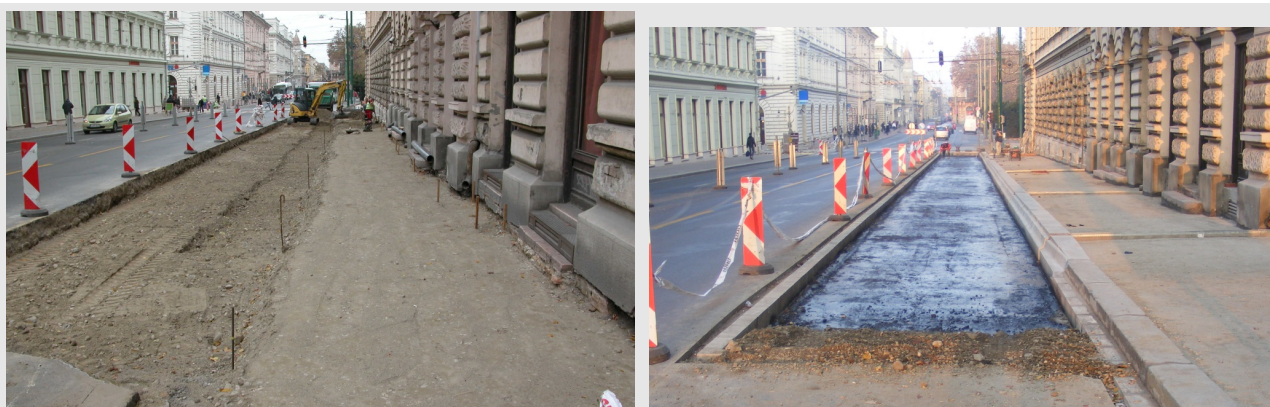
The construction company's first job was to prepare a temporary traffic layout during the construction. Since there are four lanes in this road, it seemed to be relatively straightforward to give out one lane for the construction, and one more for the machinery and for storage area. This however was not allowed by us, since the trolleybus service was not allowed to be interrupted. The catenary lays here above the two lanes, and the trolleybuses cannot infinitely get out of under the wire (4,5 meters maximum). That is why we prescribed to the construction to use the end of the site to enter, and forbade to use the neighboring lane. The construction company accepted, and rearranged its work in a way, that they mostly used the construction site for loading, unloading, and stored their material elsewhere. Thanks to the unusually relatively warm nights, the pouring of the concrete was possible to do during one night's service brake. (In case of colder weather we would have given a day of replacement of trolleybuses on one Sunday, because the pouring of the concrete was only possible to do without interruption, and could only be performed from the neighboring lane.)

*Two stages of the reconstruction of the trolleybus stop. The neighboring lane were mostly kept free for traffic.*

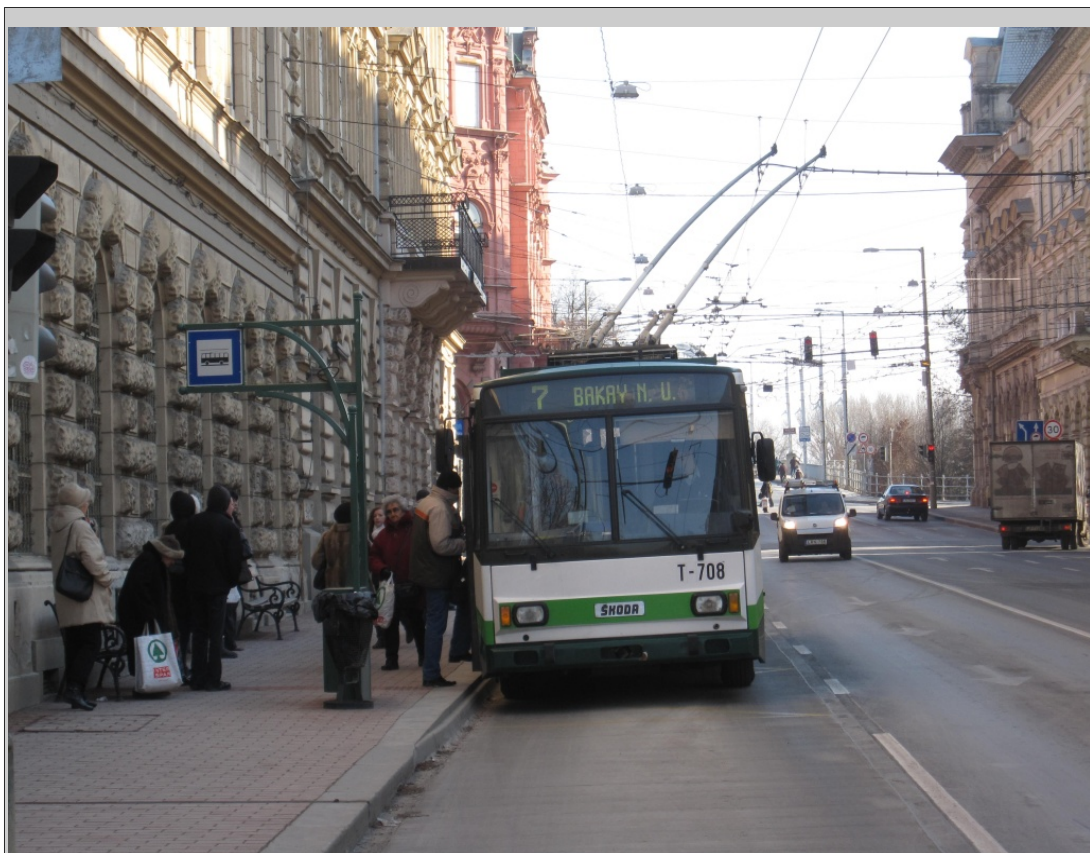
*The stop and the catenary after reconstruction, in January 2012*
